Use Attainability Analysis

WBID 0948 Tributary to Strobel Branch

Submitted by
SES, Inc.

To
Missouri Department of Natural Resources
Water Protection Program

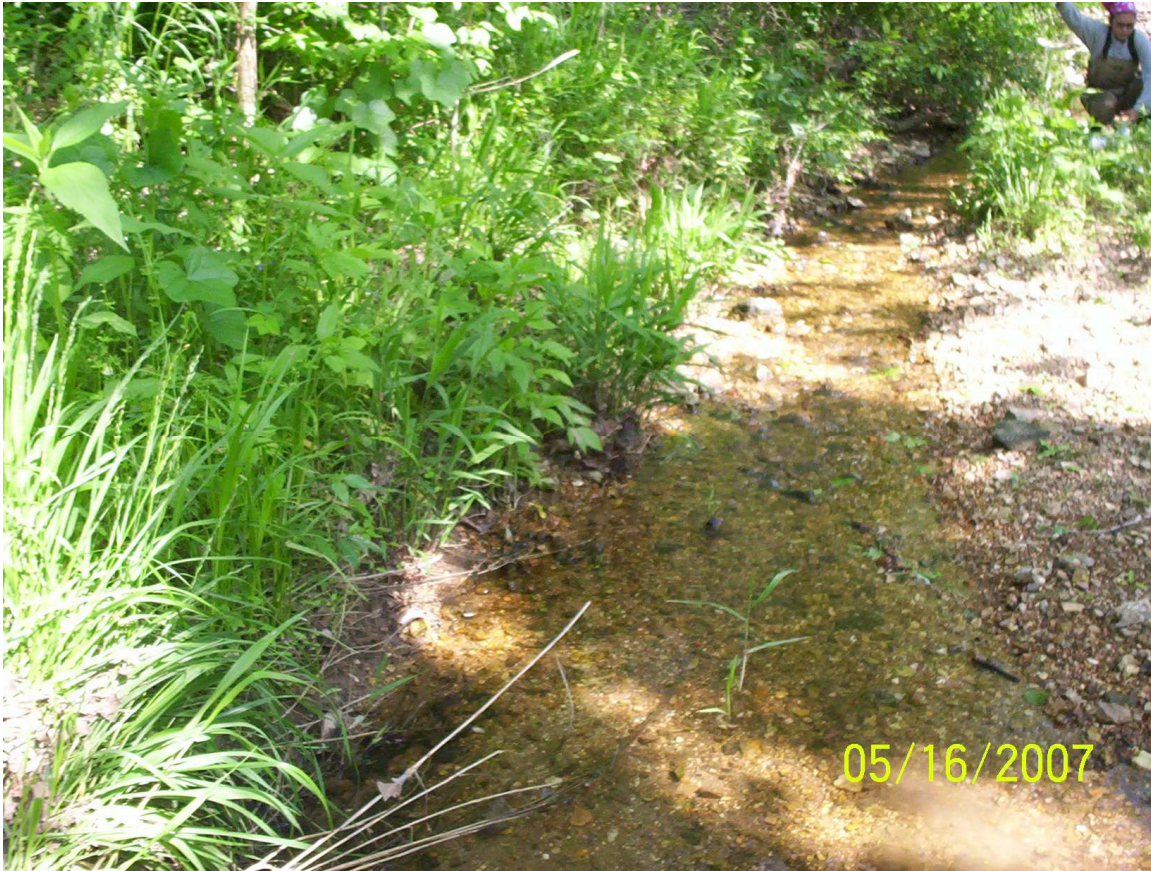
Photo 69

WBID # 948 **Site #** 1
Mark # 32 **Dissolved Oxygen (ppm)** 7.8
Upstream Views Physical Dimensions: Is there any water present at this view? yes

% of Channel Feature				
Riffle	36				
Run	0				
Pool	64

% Cobble	% Gravel	% Sand	% Silt
47	53	0	0
% Mud/Clay	% Bedrock		
0	0

Site 1

Downstream

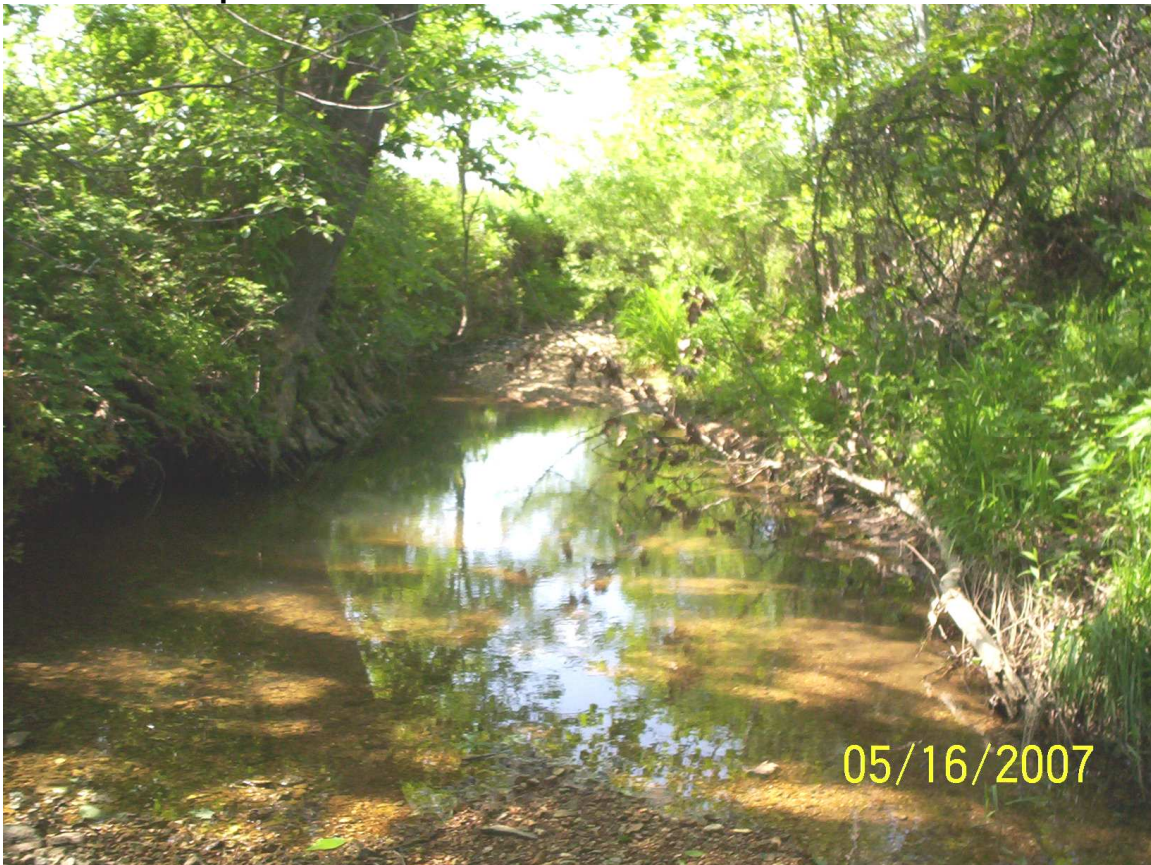
Photo 68

Site 1

Upstream

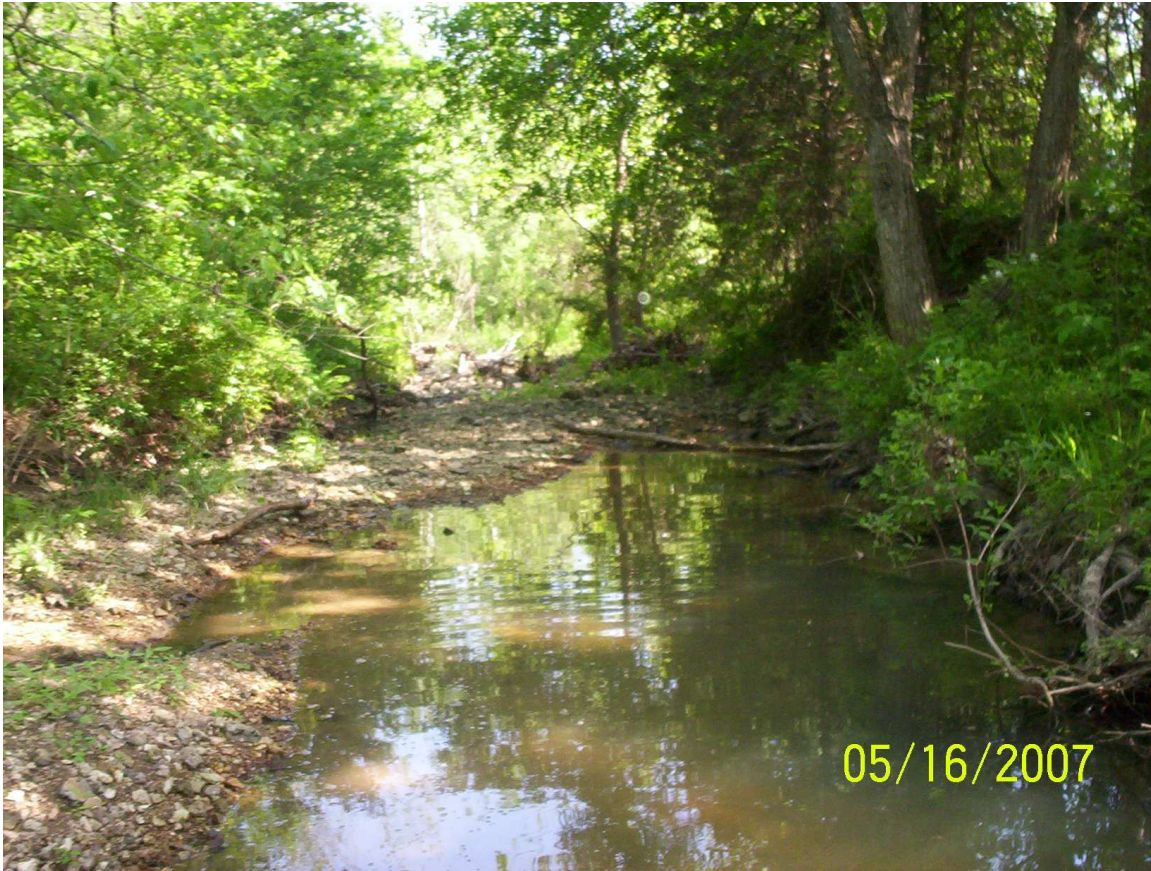
Photo 70

WBID # 948 **Site #** 2
Mark # 33 **Dissolved Oxygen (ppm)** 5.9
Upstream Views Physical Dimensions: Is there any water present at this view? yes
 If so, is there an obvious current? no

% of Channel Feature				
Riffle	36				
Run	0				
Pool	64

% Cobble	% Gravel	% Sand	% Silt
71	15	0	14
% Mud/Clay	% Bedrock		
0	0

Site 2

Downstream

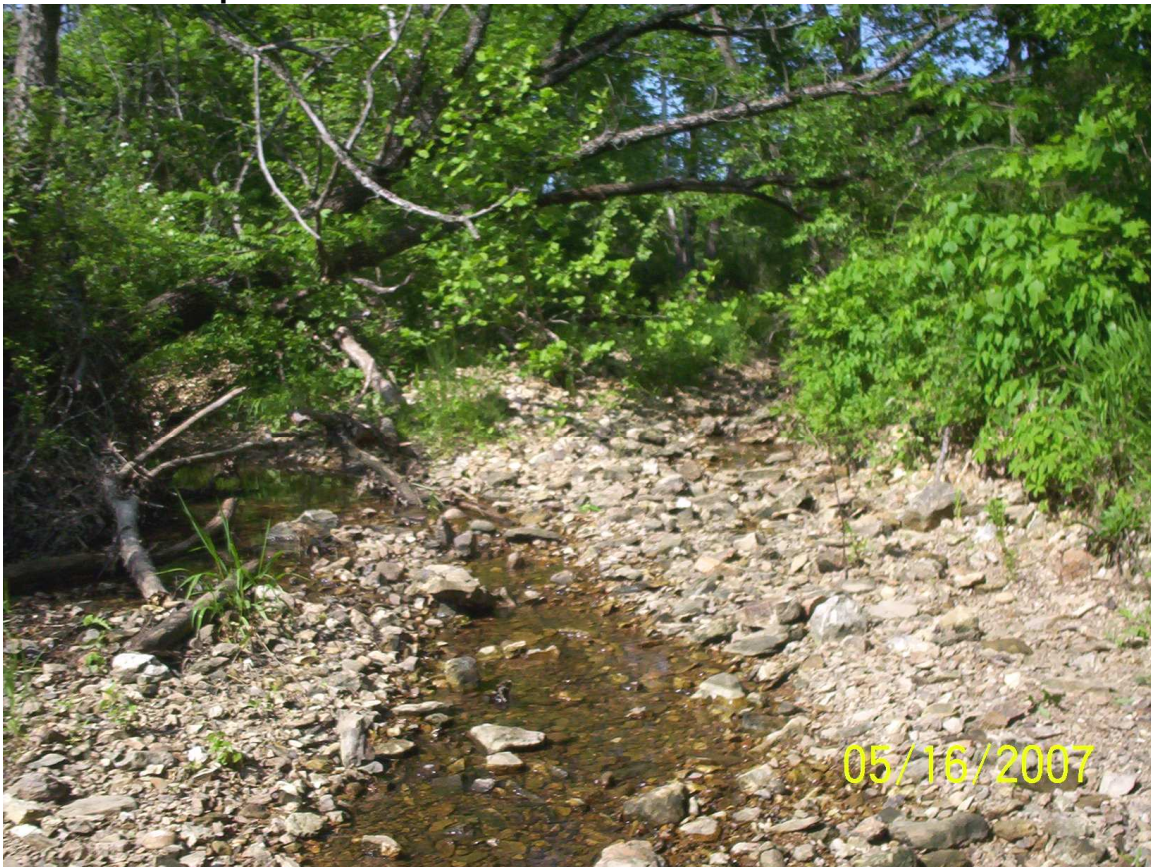
Photo 71

Site 2

Upstream

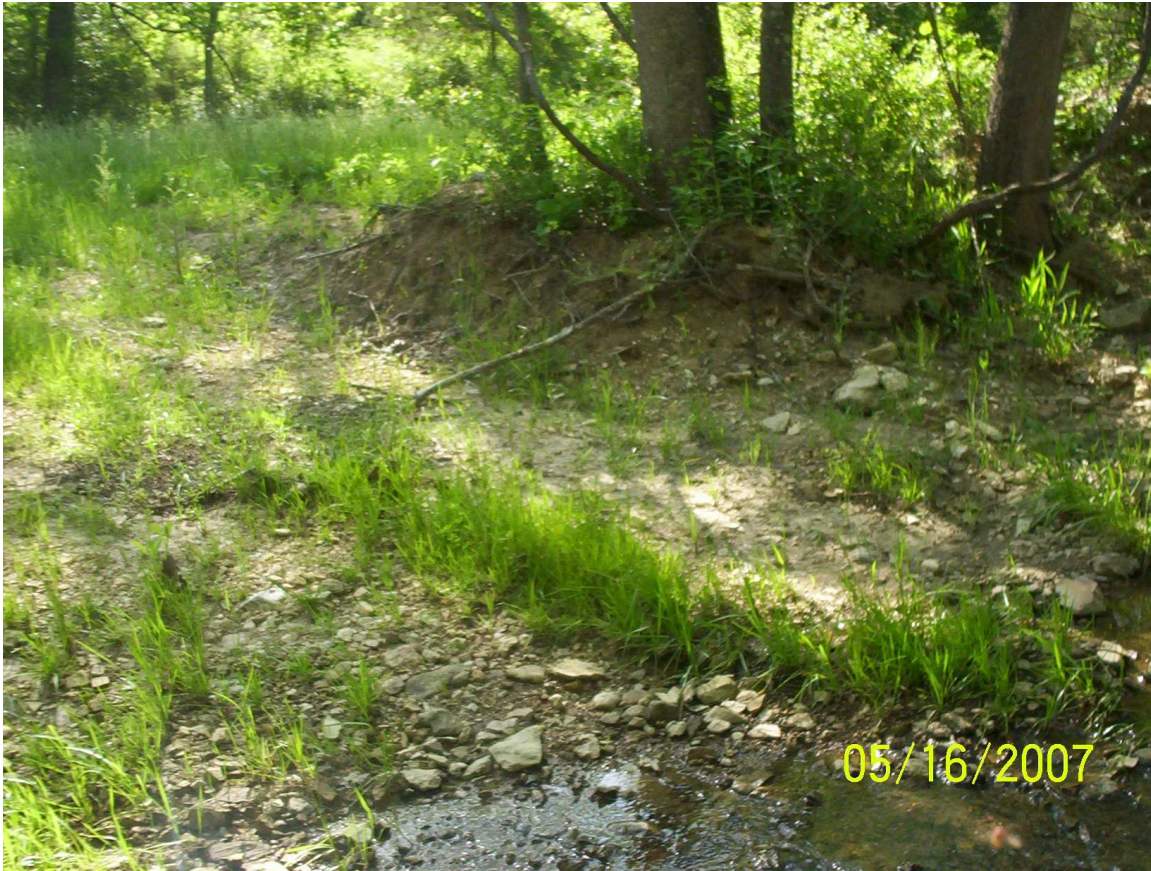
Photo 72

Roads: pic #72	Rope swings	Foot paths/prints	Dock/platform
Livestock Watering	RV/ATV Tracks	Camping Sites	Fire pit/ring
NPDES Discharge	Fishing Tackle	Other:

Site 2

Roads

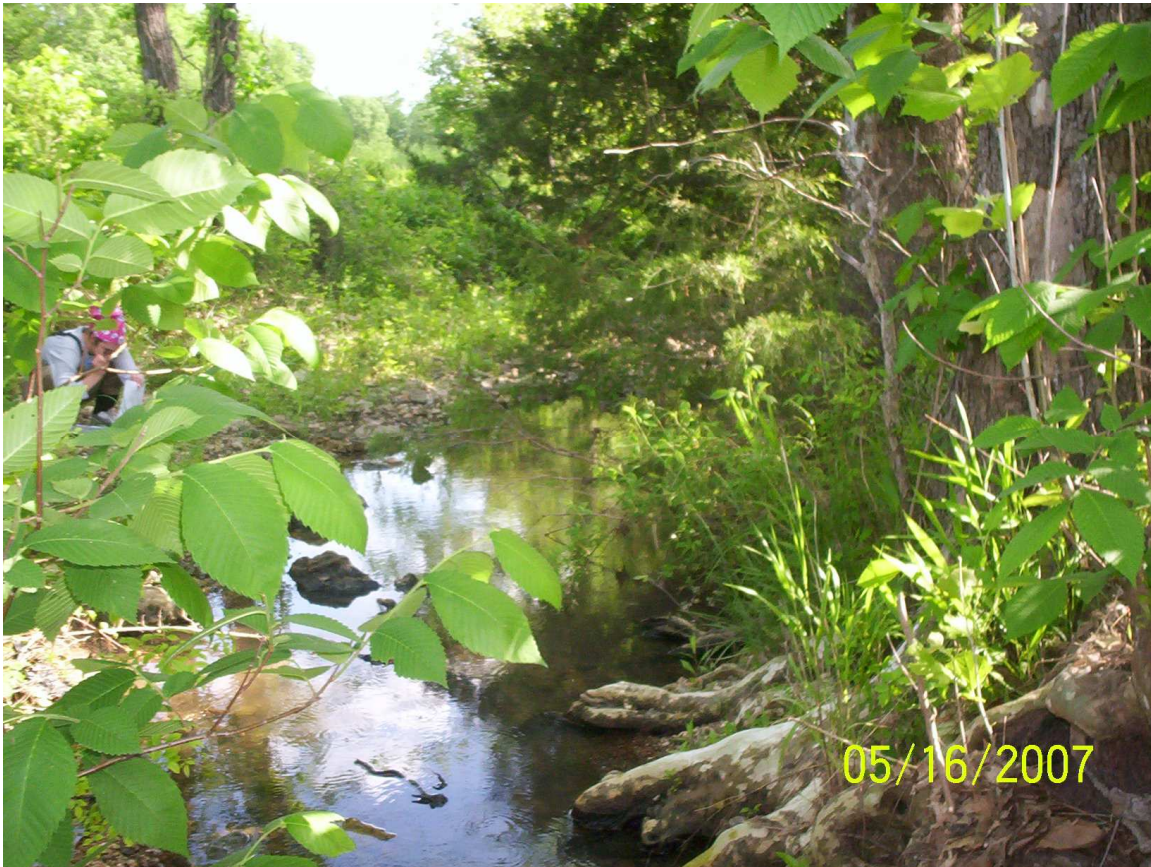
Photo 74

WBID # 948 **Site #** 3
Mark # 34 **Dissolved Oxygen (ppm)** 5.7
Upstream Views Physical Dimensions: Is there any water present at this view? yes
 If so, is there an obvious current? no

% of Channel Feature				
Riffle	45				
Run	0				
Pool	55

% Cobble	% Gravel	% Sand	% Silt
77	23	0	0
% Mud/Clay	% Bedrock		
0	0

Site 3

Downstream

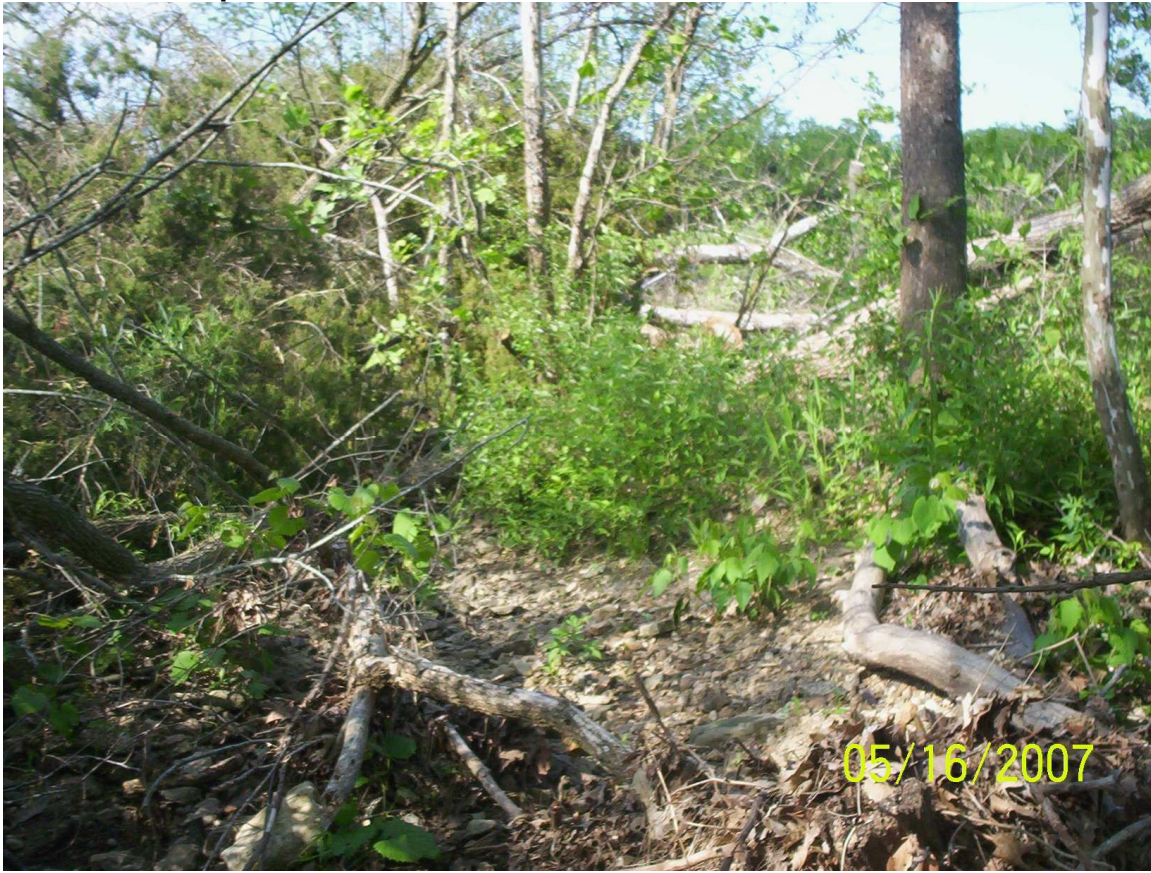
Photo 73

Site 3

Upstream
